# **LOUISIANA DEPARTMENT OF WILDLIFE & FISHERIES**

**WATERBODY MANAGEMENT PLAN SERIES**

**LAKE MARTIN**

**LAKE HISTORY & MANAGEMENT ISSUES**

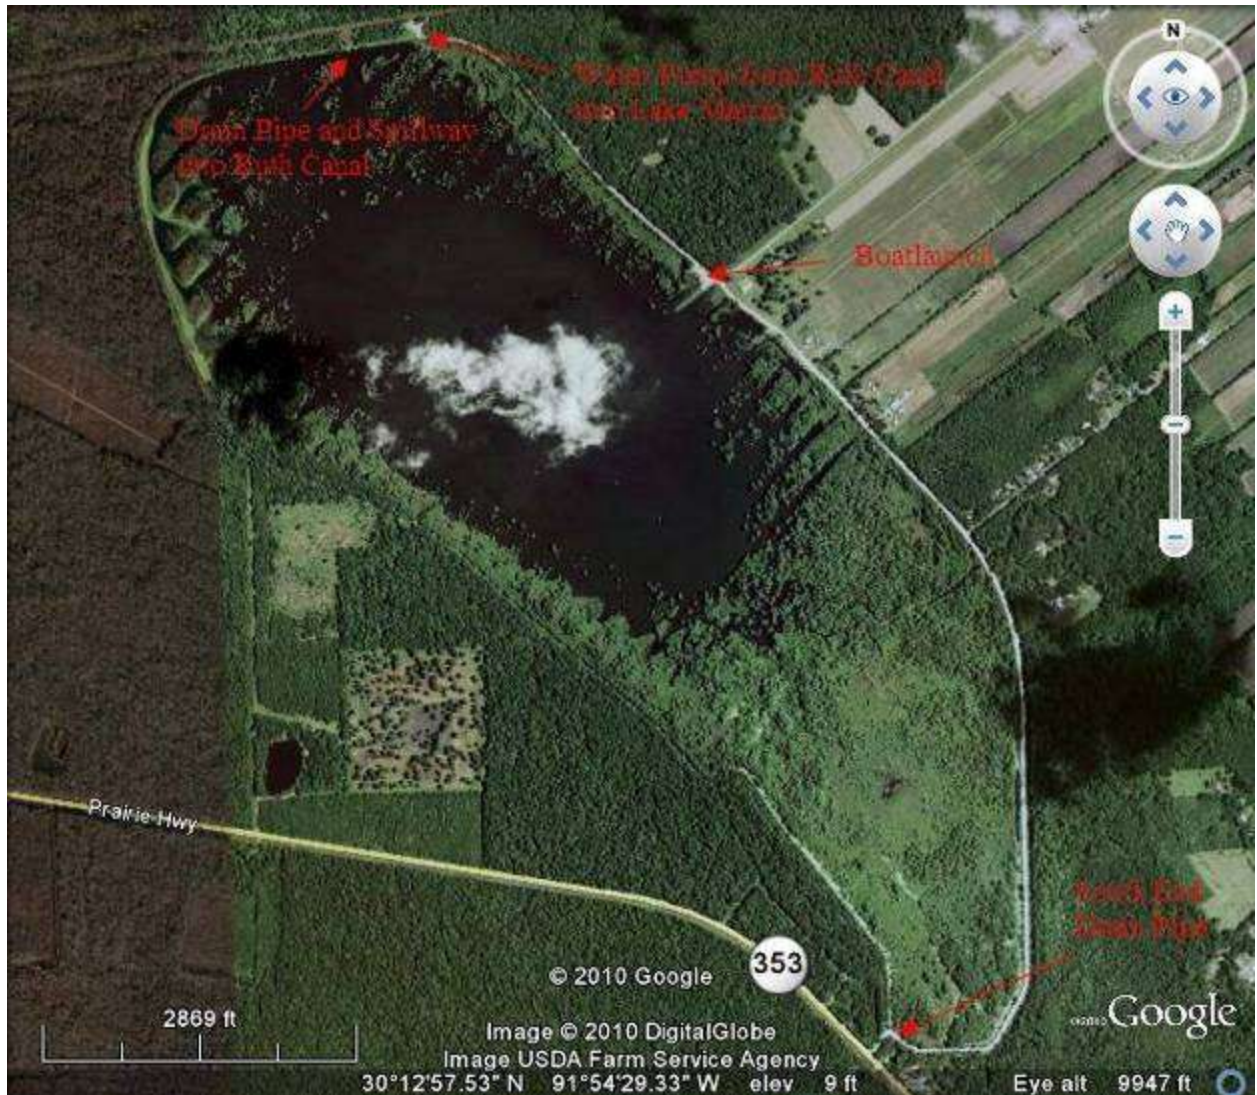
## APPENDIX I.

Map of Lake Martin depicting water control structures, pumping station, spillway and Boat Ramp.

Map with locations of boat ramp (**Appendix I**).
